# Acoustic Camera

### A new modular design concept for acoustic arrays

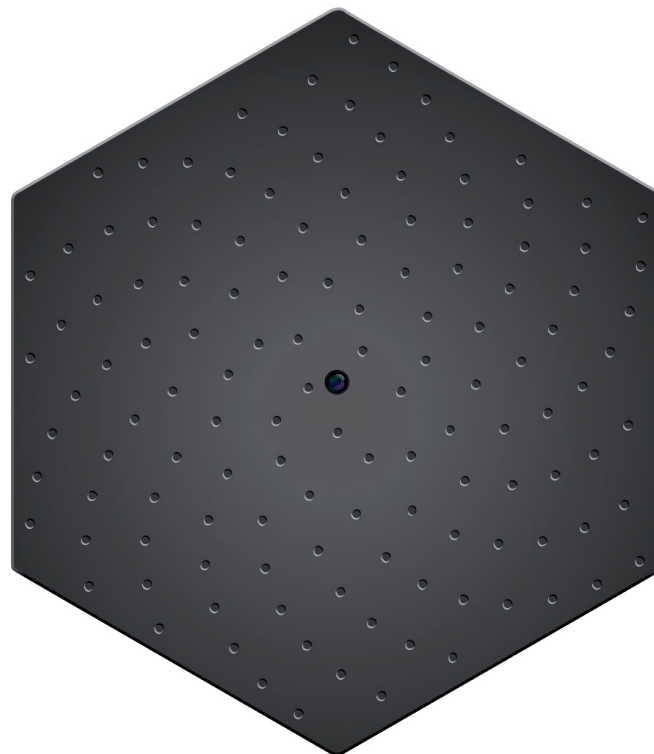
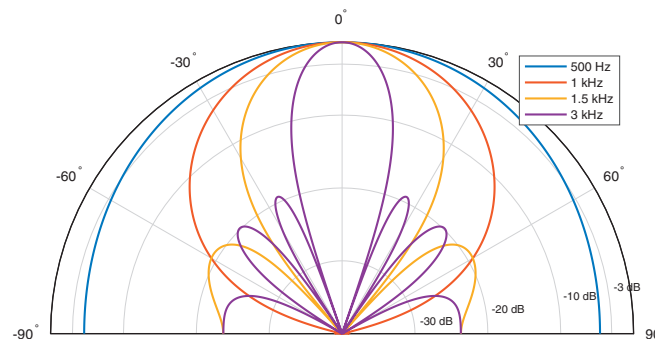
*Array geometry and beam pattern for Hextile*

With a single Hextile, the user has a small, portable and lightweight acoustic camera that can be used for a wide range of measurement situations. The Hextile is a USB based acoustic camera, with a single USB cable for both power and data transfer - no extra battery cable needed. The array is made from robust and lightweight aluminium, has 128 MEMS microphones, and is less than 3 kg in weight while having a maximum diameter of 46 cm. The low frequency limit for the Hextile is 410 Hz.

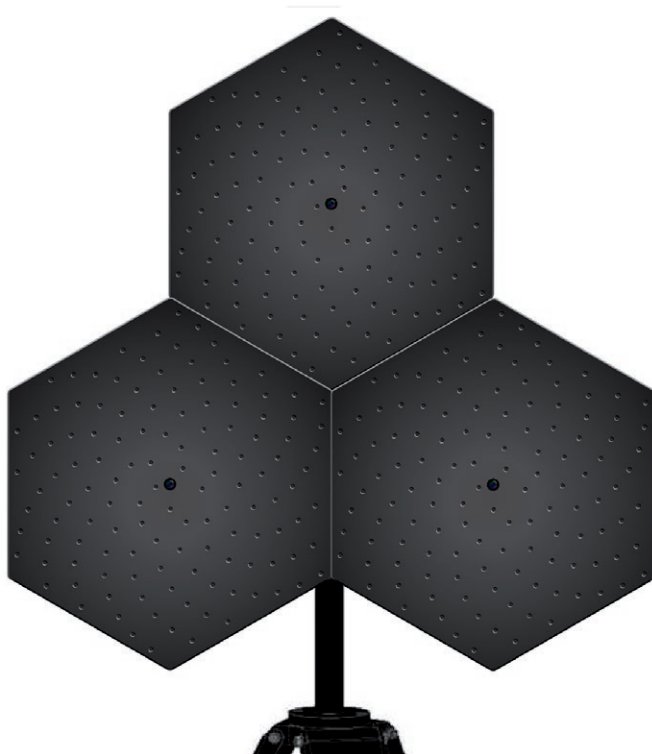
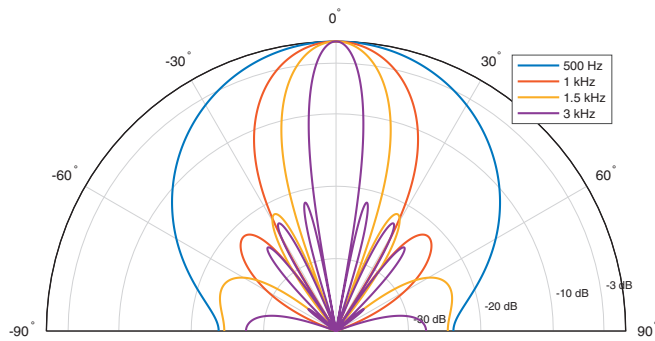
*Array geometry and beampattern for Multitile*

For users that require better resolution both in lower frequencies and overall, three single Hextiles can be combined to a larger Multitile system, consisting of 384 microphones with a maximum diameter of 96 cm. The low frequency limit for the Multitile is 220 Hz.

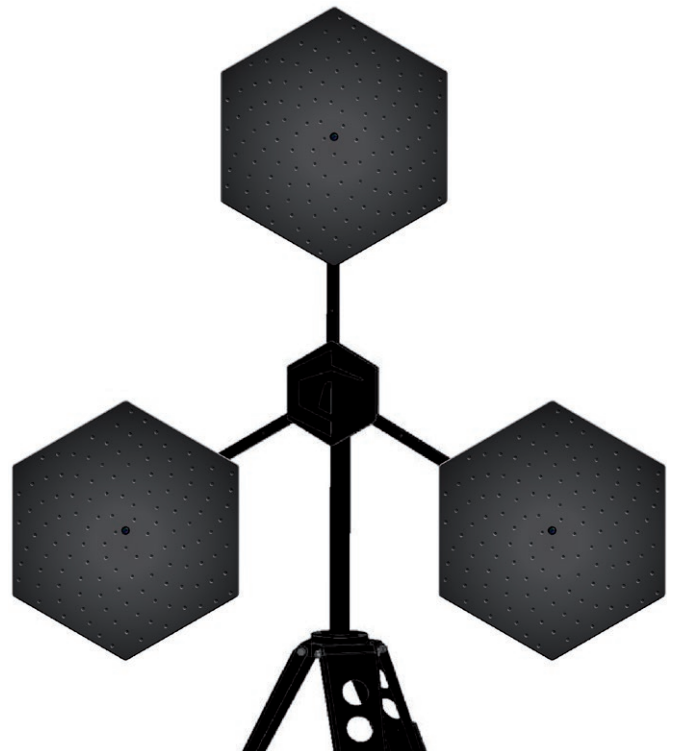
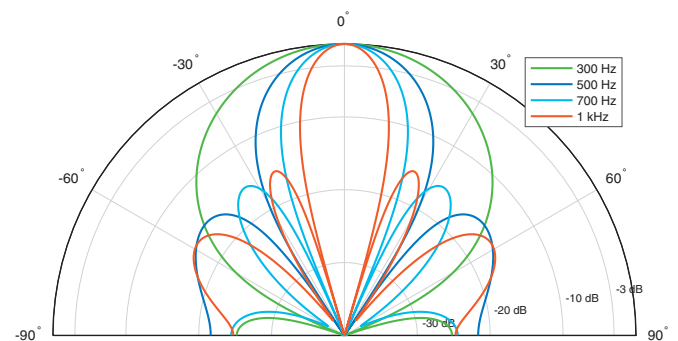
*Array geometry and beampattern for Multitile-LF*

For special low frequency applications below 1 kHz, it is also possible to utilise the Multitile in the low frequency configuration as the Multitile-LF. By placing the individual Hextiles further away, the maximum diameter of the complete array system is increased to 1.46 m, making it ideal for low frequency measurements. The Multitile-LF is for low frequency measurements below 1 kHz, with a lowest frequency limit of 120 Hz.

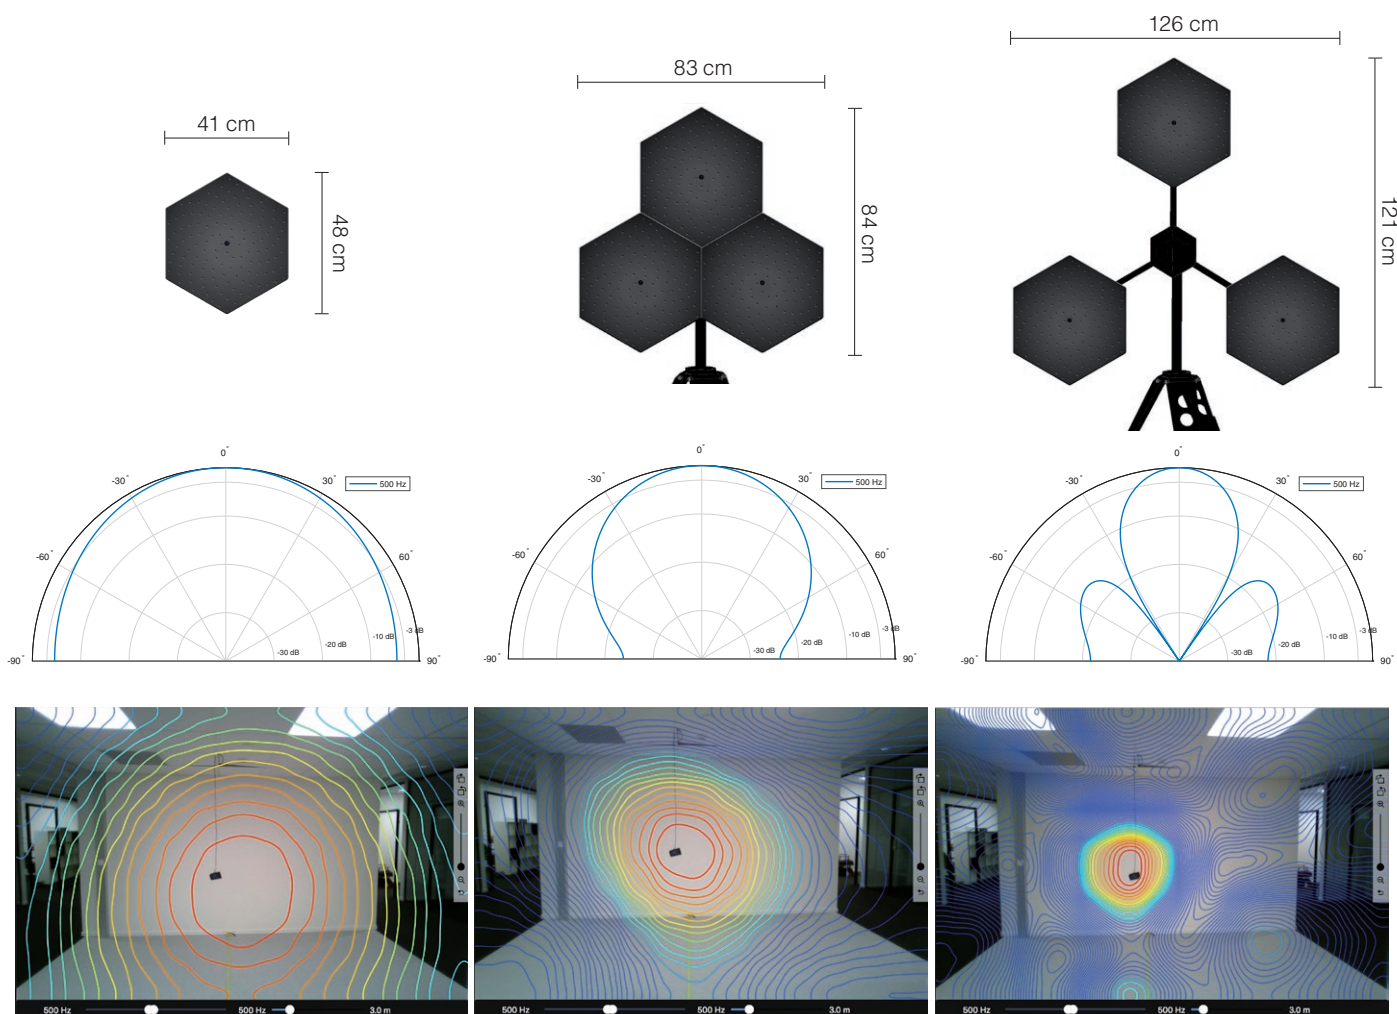
At the top are the different array configurations used for the recordings, with a 128 element Hextile, a 384 element Multitile, and

a 384 element Multitile-LF. The diameters of the array configurations are 46 cm, 96 cm, and 1.46 m respectively.

The second rows show the beampattern for the different array configurations at 500 Hz and 3 dB dynamic range. As can be seen the beampattern gets more narrow, thus giving better resolution, as the overall array size increases.

Lastly the plotting results from the three different array configurations recorded on a real noise source are shown with 3 dB dynamic. The improvement in terms of resolution and pin-pointing the source is clearly visible when using bigger equipment.

Array geometry, beampattern at 500 Hz, and plotting results of pink noise source filtered at 500 Hz for Hextile, Multitile and Multitile-LF

The biggest improvement when going from a single Hextile to the two different Multitile configurations is best demonstrated on a low frequency source. Seen below are the results from recordings on a single omnidirectional noise source emitting pink noise, with the colour plotting being done when the input signals are filtered at 500 Hz. This should give a direct comparison of the low frequency capability of the different arrays.

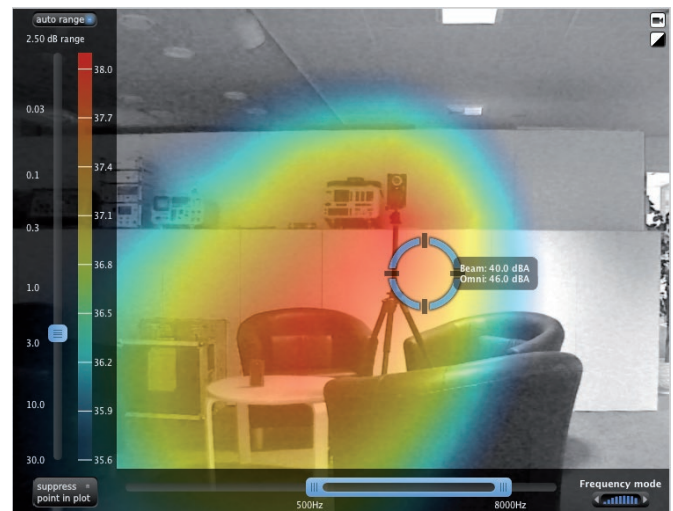
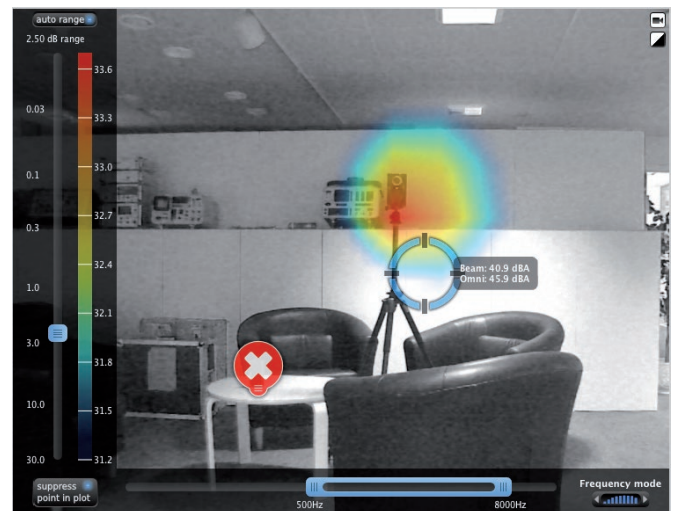
by the stronger source. Seen in the image below is a situation where two equally strong sources are positioned close to one another, and the resulting colour plot will display a single large source. In such situations the acoustic eraser feature may prove valuable. This function will add a red circle to the screen that can be dragged to any point, and remove the source from that point. This is highly effective when several noise sources are present. As seen on the pictures the acoustic eraser completely removes the source where the suppress point button is positioned. The virtual microphone can further be positioned on the source of interest.

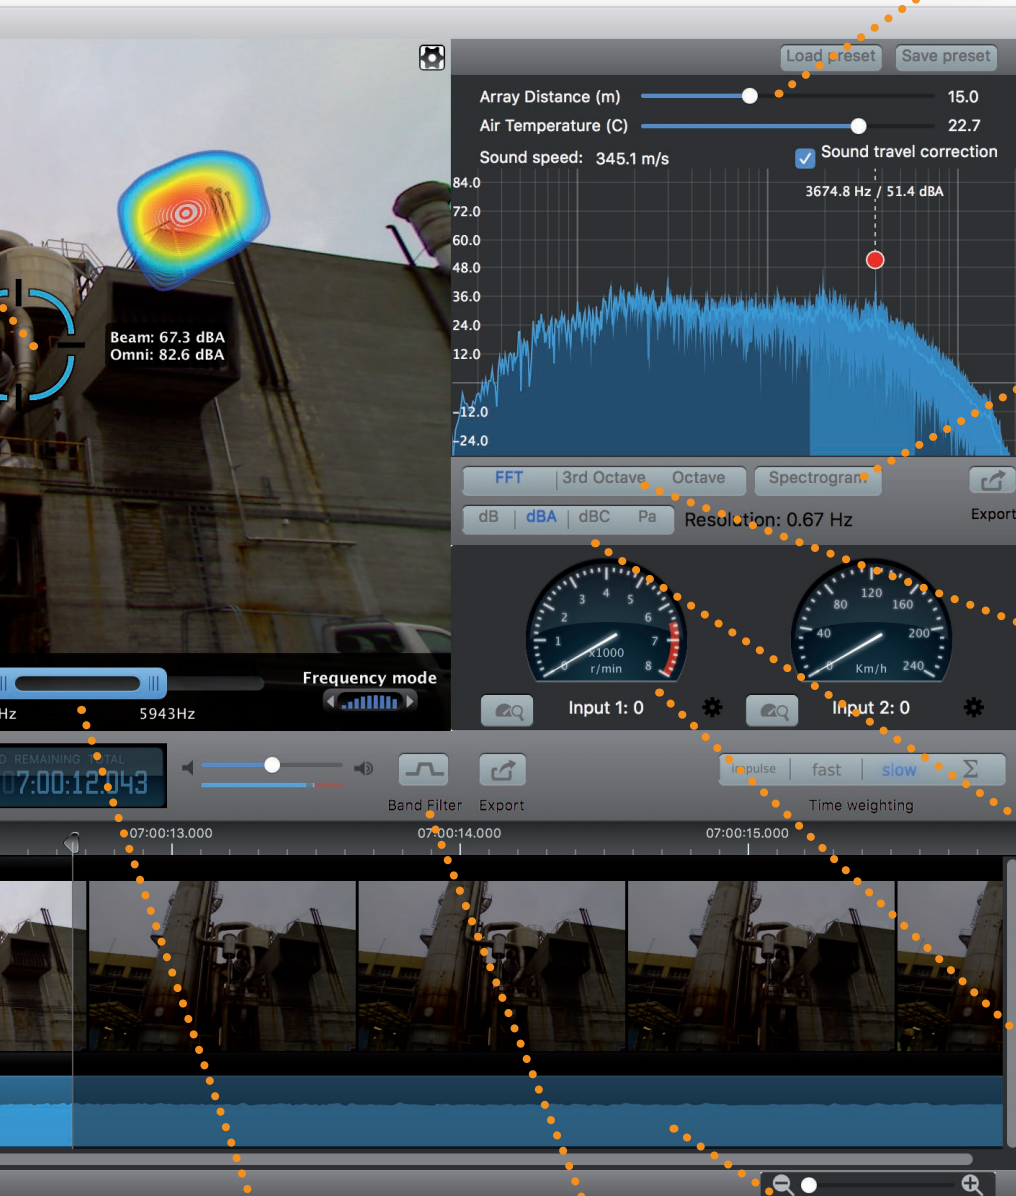
Set the focal distance

Display spectrogram

Display the spectrum as FFT, 1/3 or 1/1 octave

A, C or flat frequency weighting selection

RPM and order tracking

Set the frequency range

Listen to broadband or selected frequency band

Sound level history

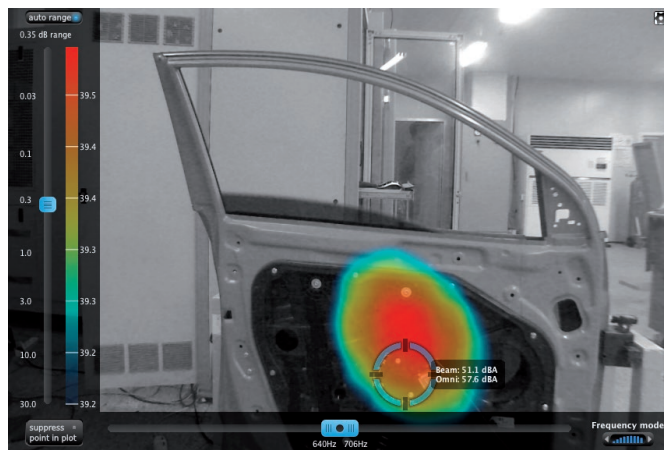
In addition to the high pitch squeak noise, sound from the electric engine could also be heard which was around 670 Hz. Since this sound was present during the entire recording, it could be easy to misinterpret the results and pinpoint the source of the high pitch noise to the wrong location without doing proper analysis. As seen in the image below, the location of the electric engine was in the middle of the door.

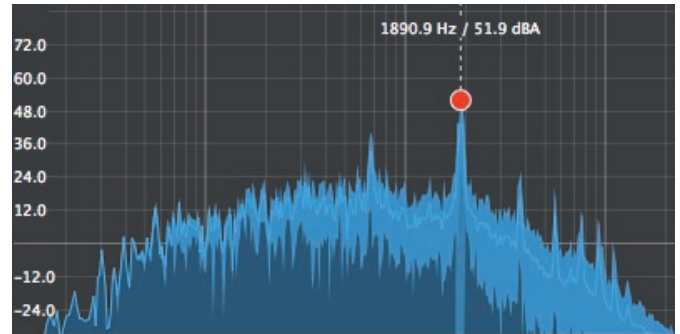
As opposed to the stationary sound from the electric engine, the high pitch squeak noise was only happening for a brief period of time, around 300 ms. By defining a scene in the sound level indicator

pane of the acoustic camera software, it was then possible to analyse events happening only within the time frame of the extent of the scene. The scene is made by simply dragging the cursor over the region of interest in the software.

Now by calculating the average spectral density over that part of the recording, it was easy to see that in addition to the noise from the electric motor around 670 Hz, a high pitch tonal noise with a fundamental frequency around 1890 Hz could also be seen in the frequency spectrum. In addition harmonics of the fundamental frequency up to the 7th harmonic was visible in the spectrum.

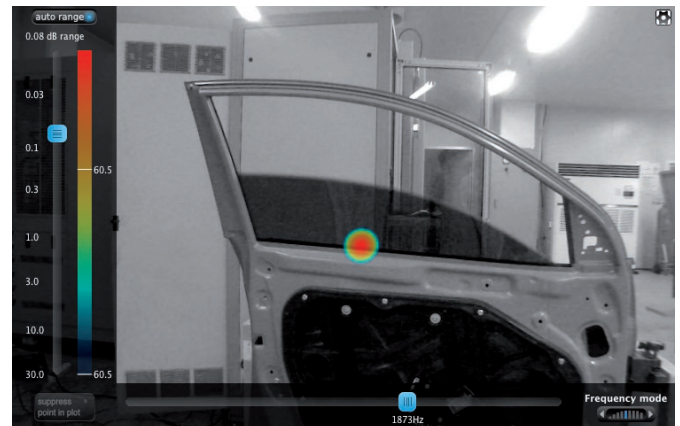
Now by filtering the frequency content of interest around the fundamental frequency, it was possible to get a clearer indication of the position of the source of the high pitch squeak noise as seen below. Due to the tonal nature of the noise it was possible to switch from the ordinary, robust wideband algorithm, to the adaptive algorithm for narrowband applications. This further helped in pinpointing the exact location of the problem. Higher resolution could also be achieved by zooming further in the image.

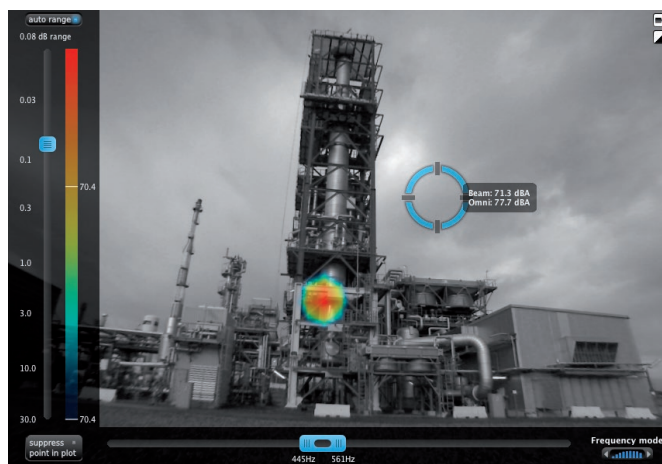
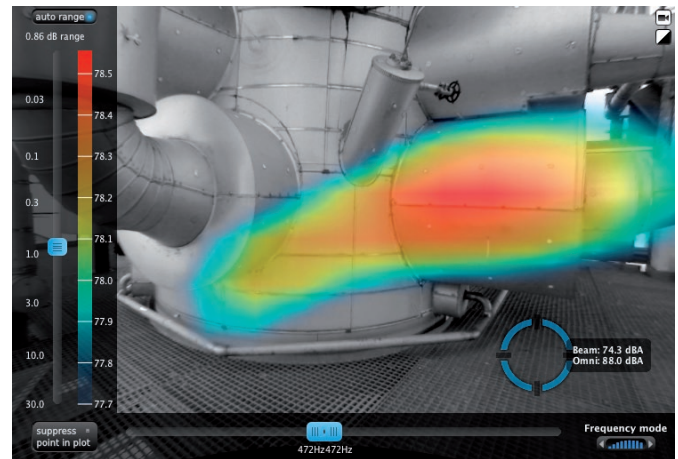
By positioning the center of the array towards the pipe and adjusting the frequency to display only coloring within the 500 Hz 1/3-band, the noise source was located within seconds, and the source producing the tonal part from the pipe was detected. Measurements from different measurement positions also confirmed the source location.

By placing the virtual microphone on the localised source and using the spectrogram function, it was easy to verify the position of the source emitting a tone at 460 Hz.

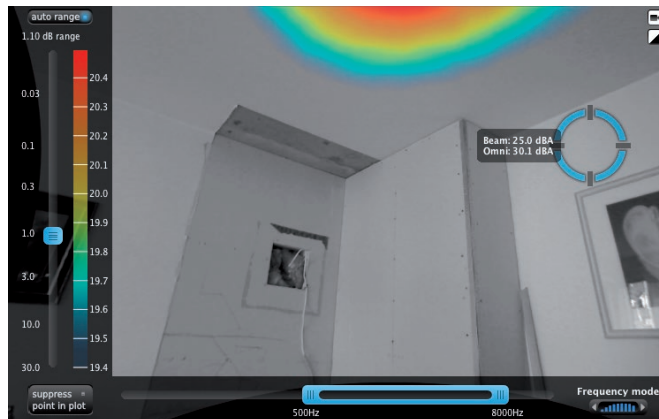
When filming at the location of the encased pipes in the corner of the living room, the acoustic camera did not pick up any energy at that position, but rather the colouring was upwards towards the roof and outside the field of view of the camera at that measurement position.

This was a very strong indication that the origin of the noise was in fact located somewhere else, and the camera was directed accordingly for the subsequent measurements.

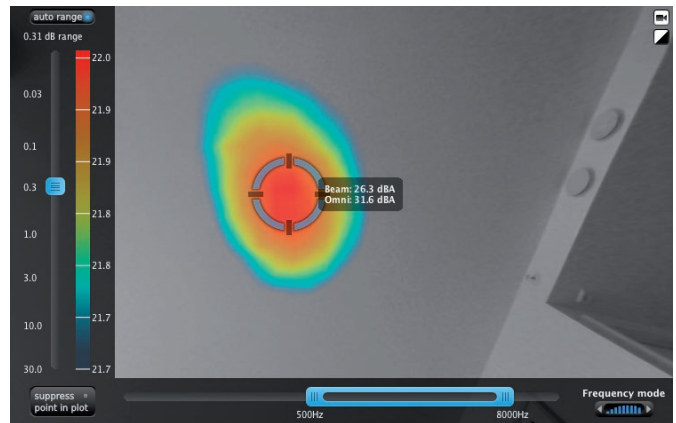
When pointing the camera towards the ceiling it became apparent that the source was at this position. No other spots, either from the embedded pipes in the corner of the living room, or from the hallway, had any visible colouring, and could be excluded as the likely position of the origin of the source.

By using the virtual microphone, which enables the user to listen to a specific position in both real time and in a recording, one could clearly hear the sanitary noise from the recorded position at the roof. Also by enabling the bandpass filter one could further be able to filter out background noise and very clearly hear the sanitary noise from the piping. Based on these measurements one could deduce that the water pipes in were in fact not positioned as previously thought.

In addition to measurements in the living room subsequent measurements were also made in the two bedrooms. These measurements displayed the same result, the energy of the noise did not come from the walls, but were confined to the roof. All in all this was a very strong indication that the problem was piping located in separating floors between apartments.

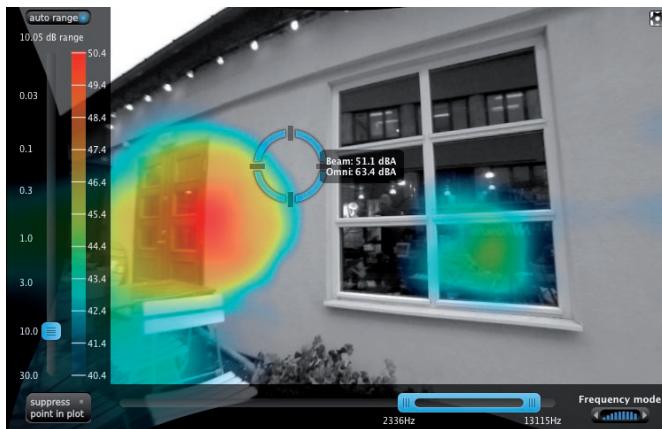
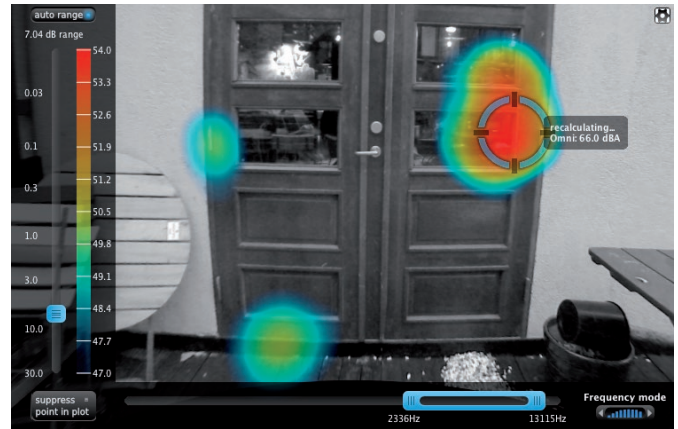
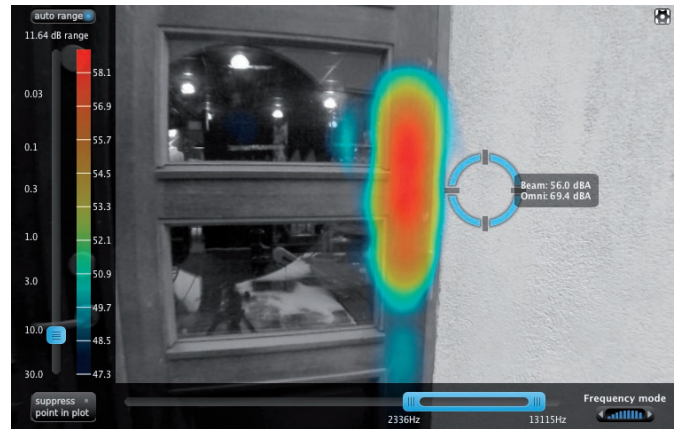
The wall between the café leading to the patio consists of both a door and several windows. The first step consisted in seeing what made the biggest noise contribution. As seen in the image below, where the dynamic range is set to 10 dB, the door had a noise contribution that was approximately 10 dB higher than the nearest window.

By focusing on the door only it was further possible to locate the exact position of, and zoom in on, those weaknesses as seen in the images below.

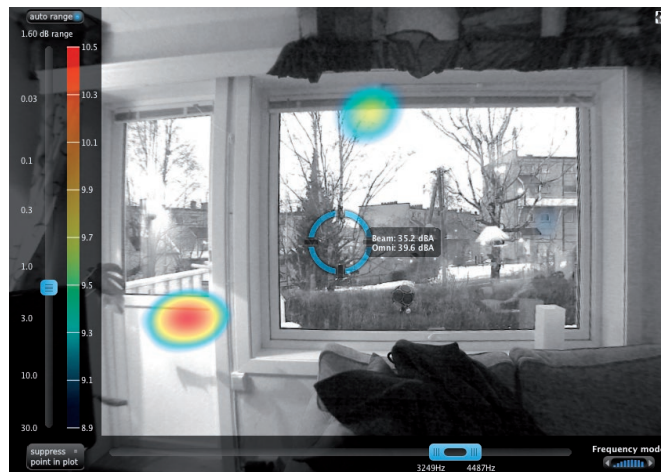
In addition to using traffic as noise source, measurements were made by placing an omnidirectional loudspeaker emitting white noise on the outside of the facade. This created a more stationary sound field on the outside of the structure, and made detection of small cracks and gaps in the structure even easier.

Initial recordings when using traffic as noise source displayed a single strongest facade weakness at the top left of the living room wall. This strongest source position was also confirmed when using the omnidirectional loudspeaker as noise source. At this position a ventilation valve was installed, and most of the traffic noise came from this location.

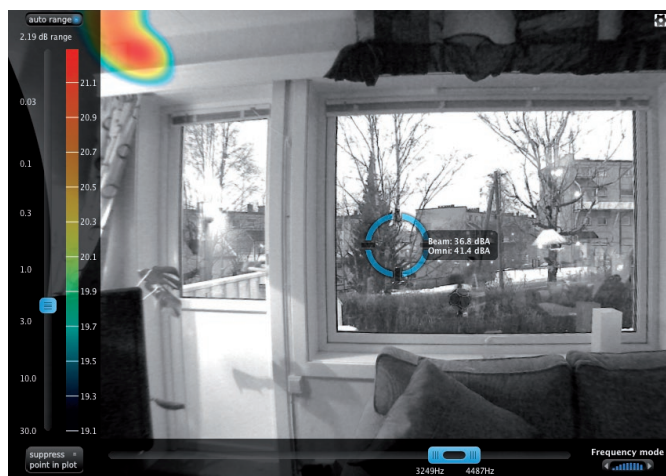
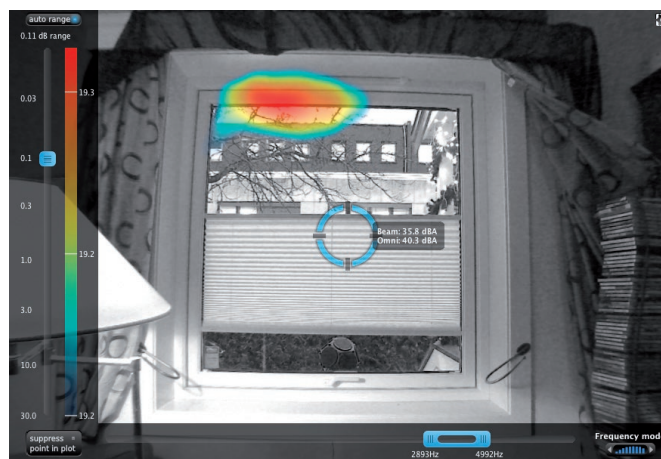
Having determined that the intake valve was the main noise contributor, this spot was covered up with a pillow to remove it from the overall noise field, and try to locate secondary sources. By filtering on a relatively high frequency band around 3 - 4 kHz, it was possible to filter out only the noise being emitted by small gaps and cracks. This produced two new possible weaknesses, one on the porch door, and another on the air valve above the window.

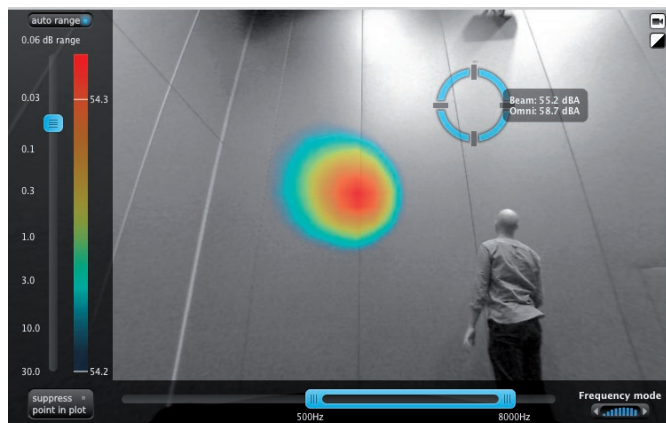
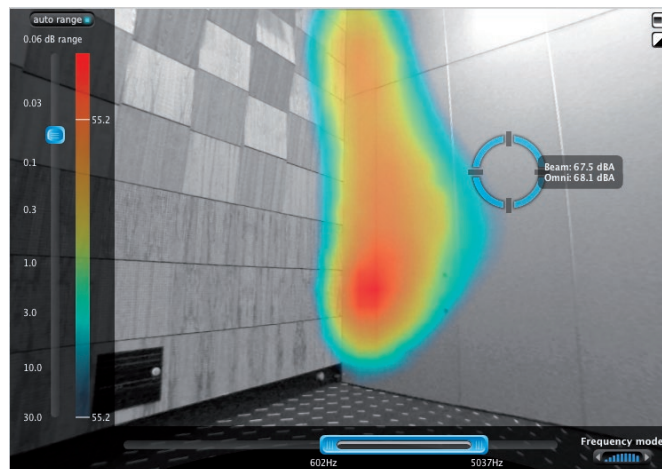
The acoustic camera was plugged into an external battery pack for easy transportation and mobility. The measurement procedure consisted of choosing two adjacent rooms divided by a modular wall of interest. One of the rooms was chosen to act as receiving room, where the acoustic camera was positioned. A noise source and omnidirectional loudspeaker generating white noise at high volume was positioned in the source room. The speaker was placed in one of the corners of the room furthest away from the dividing wall, in order to achieve as diffuse source noise field as possible.

Due to the large size of the modular walls, the camera was pointed to different areas of the walls, and several measurements were made. The individual measurements could then be examined further in post-processing analysis. Due to the source being used at high volume in the sending room, cracks and gaps in the modular walls would appear as small noise sources at specific location on the walls when recording with the acoustic camera in the receiving room. The acoustic camera was able to locate several weak spots on the walls, even though the range where differences could be discovered were for certain areas below 0.05 dB.
