# Nor848A Acoustic camera

Metro station in Taipei, Taiwan

## Verification of efficiency of noise reduction measures: Metro station in Taipei, Taiwan, May 2013

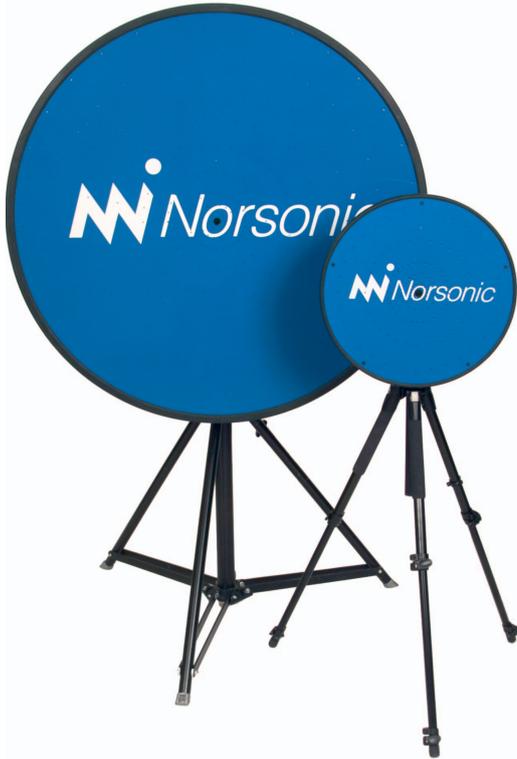
With the Nor848 acoustic camera the efficiency of a noise reduction project can clearly be shown graphically as sound level colour plot on a picture or video, in graphs with frequency components as octave, third octave or FFT or in tabular format. The function of the virtual microphones gives the operator a powerful tool to identify and evaluate single sources in a complex sound field.

For this particular case the acoustic camera immediately could present the efficiency of the noise reduction measures that had been implemented. The broadband noise transmitted and reflected from the untreated part of the bridge were about 5 dBA above the contribution from the treated area.
